SAINT JOHN RIVER BASIN
Limestone, Maine

WEBSTER BROOK DAM ME 00229

PHASE I INSPECTION REPORT NATIONAL DAM INSPECTION PROGRAM

SEPTEMBER 1981

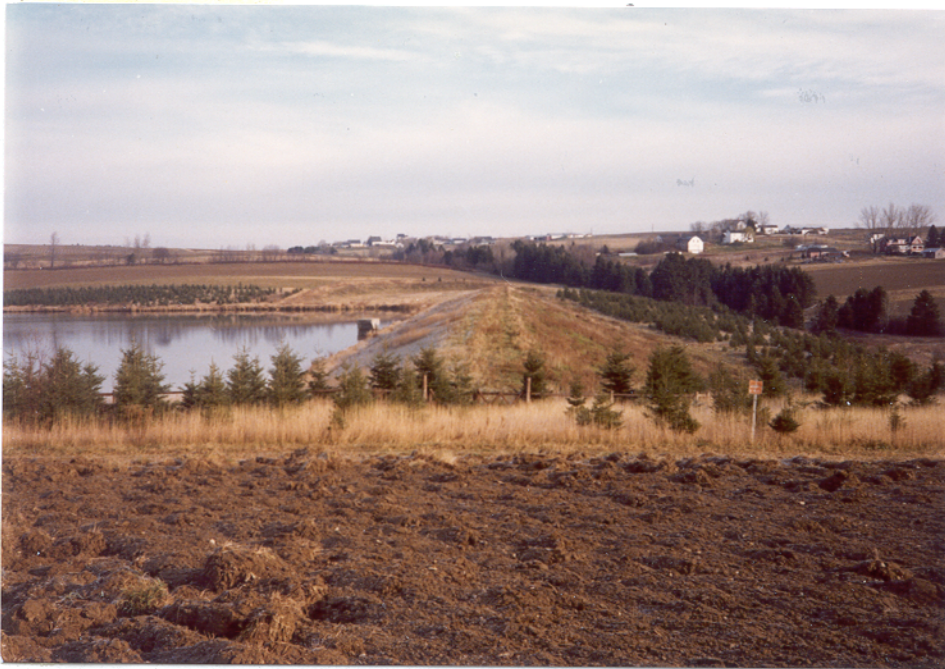
Photo #1

- b. Dam
 - (1) Crest - The embankment crest was true to line with no apparent dips, sags, cracks or other evidence of distress (Photo 1). The top of the settled dam is given as Elev. 595.0 NGVD (see drawing 7 of 21, page B-8). The top of the "constructed dam" is given at Elev. 597.0' NGVD (see drawing 4 of 21, page B-5). This 2 foot variance at the center of the dam was designed so as to allow for the natural settlement of the structure over the lifetime of the project. The visual inspection shows the crest to have a slight crown which is in agreement with the as-built drawing (Photo 1). The crest is grass covered with no pavement.

General view of
Dam from right
Abutment

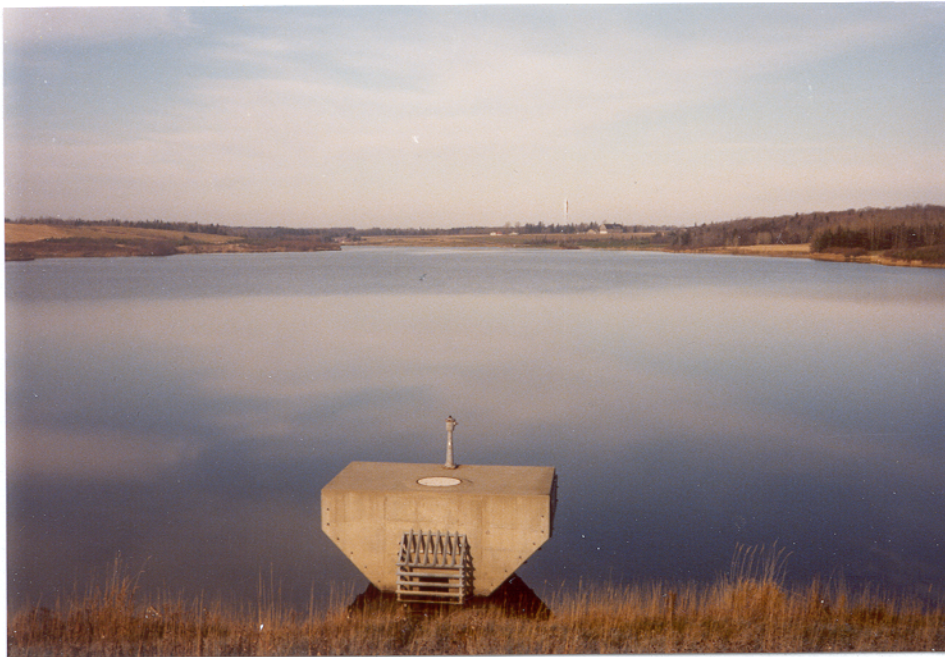
Photo #2

- (6) Instrumentation - No instrumentation was observed.
- c. Appurtenant Structures
 - (1) Principal Spillway - The principal spillway intake (Photo 2 and 3) was observed from shore. The exposed concrete and steel trashrack appeared in good condition.

View of Principal
Spillway Intake
from Crest of
Dam.

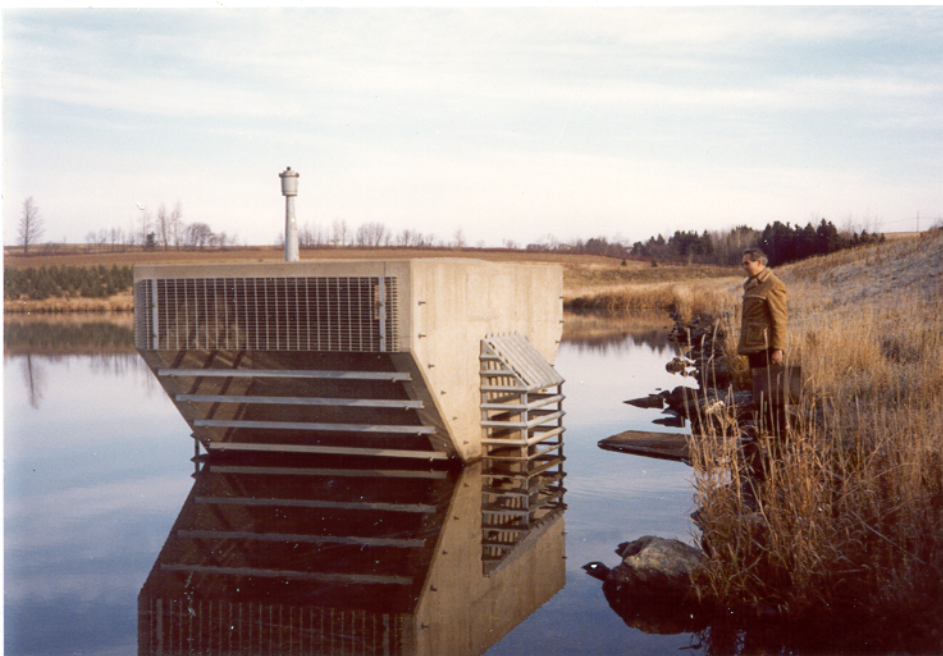
Photo #3

Close-up View of
Principal Spillway
Intake Structure

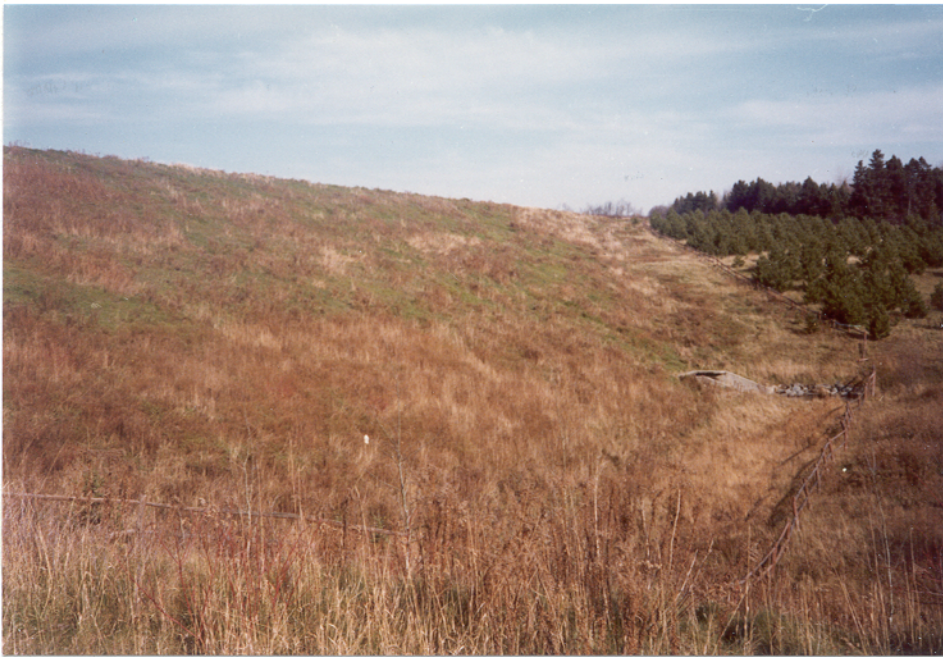
- (3) Downstream slope - The downstream slope has a well developed, tight grass cover (Photo 4). No significant gully action was observed on the slope. No slides or sags were observed.

Photo #4
View of Downstream
Slope with Outlet
Structure

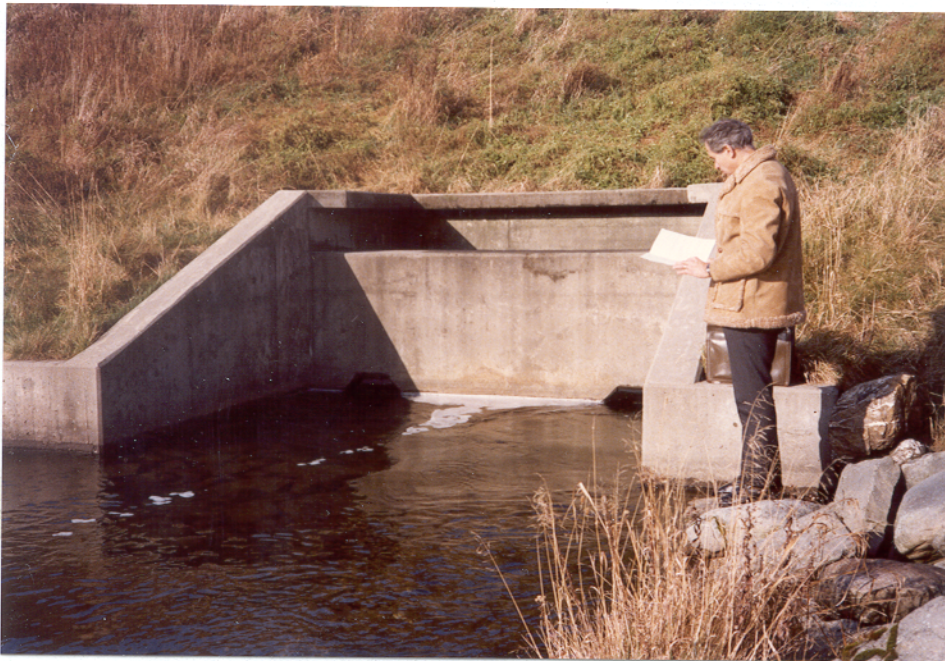
(2) Outlet works - The outlet impact basin (Photo 5) was found in good condition. All construction joints were tight. No spalling was observed. The reservoir drain inlet was submerged and could not be inspected. The outlet conduit could not be inspected. The control mechanism for the drain was reported to have been recently operated without problems by the Limestone Town Manager.

Photo #5
Concrete Outlet
Structure

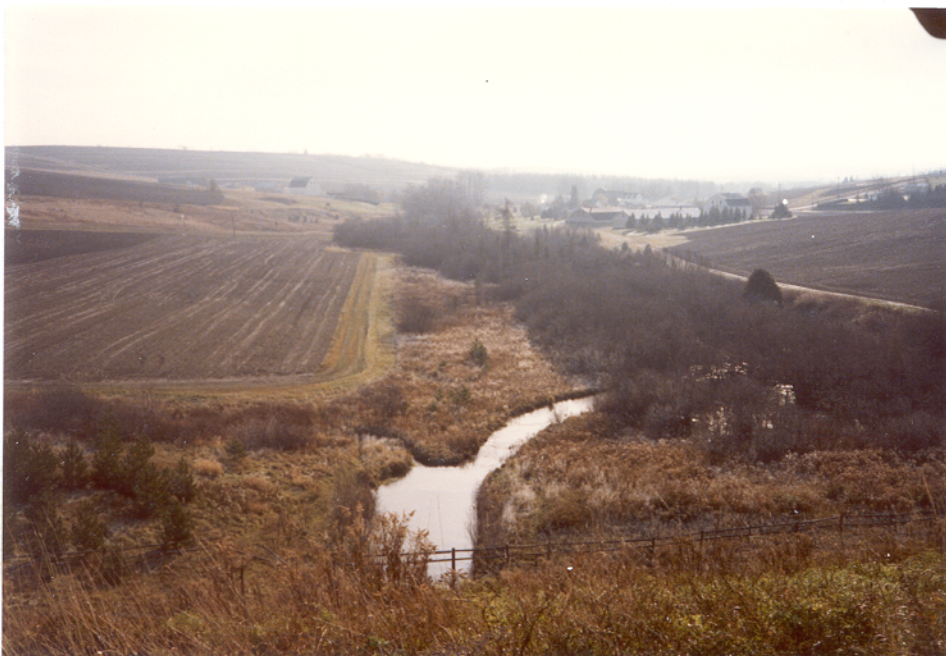
Photo #6
View of Outlet
Channel from
Crest of Dam

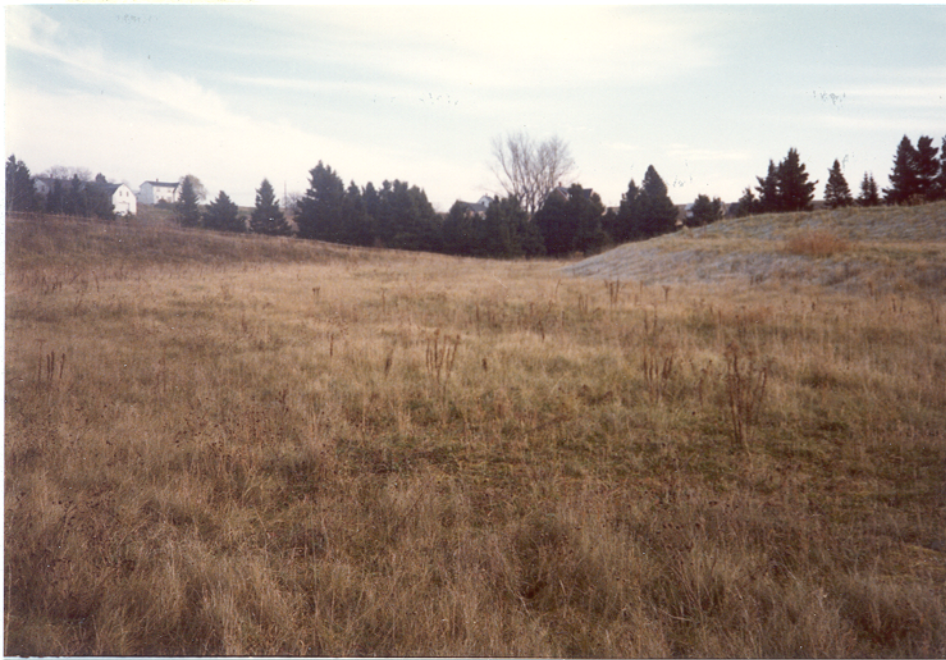
(3) Emergency spillway - The emergency spillway was clear of debris and in good condition with a well developed grass cover (Photo 7).

Photo # 7
Emergency Spillway

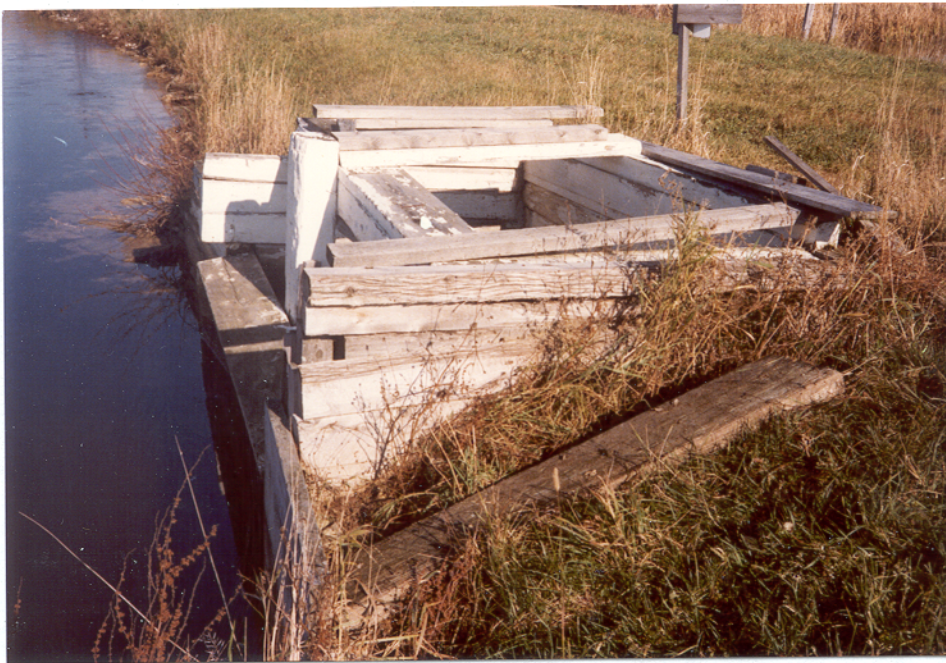
Photo # 8
Upstream Reservoir
Outlet Structure

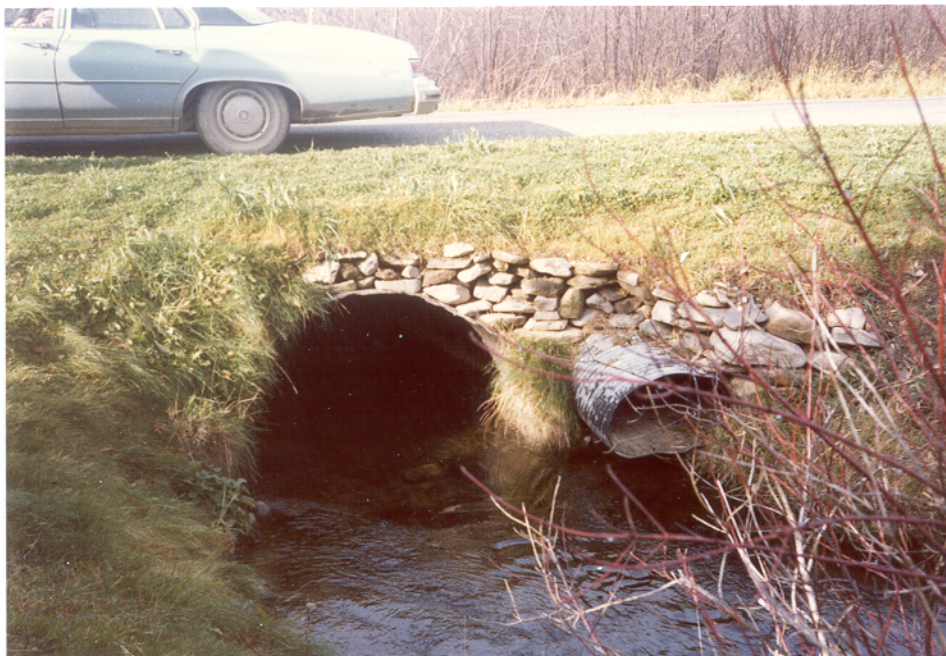
Photo # 9
Center Road
Culverts
